## **S**ustainable solutions for affordable **REtroFIT** of domestic buildings

### **WP9 - Deliverable D 9.6**

#### **Report on case studies of retrofitted buildings**

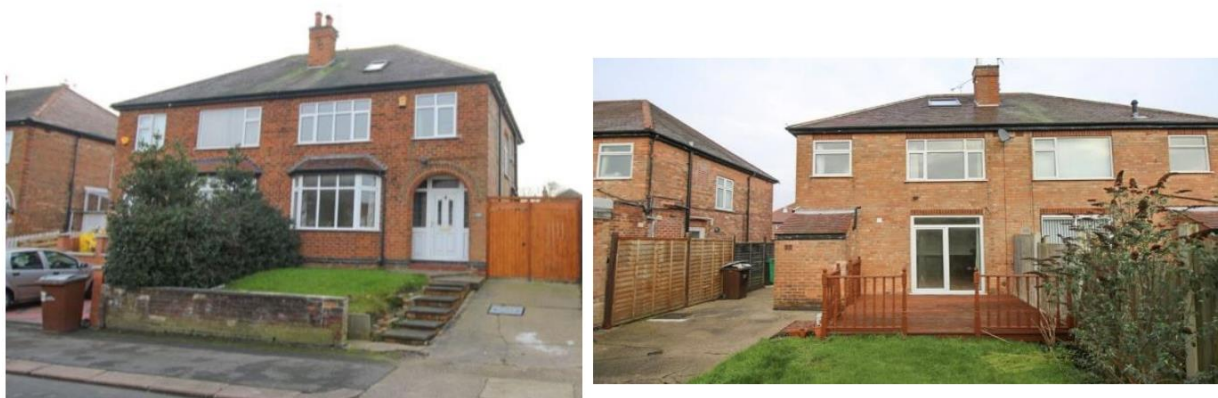
Figure 1 - Front and rear photos of Nottingham house

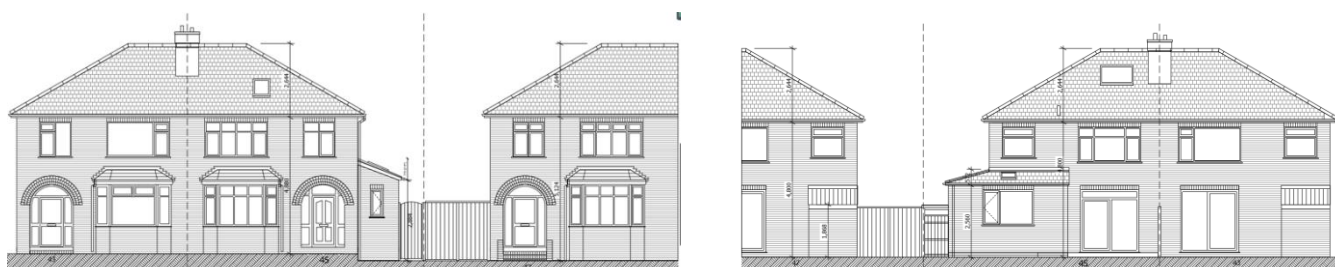
Figure 2 - Front and rear elevation drawings

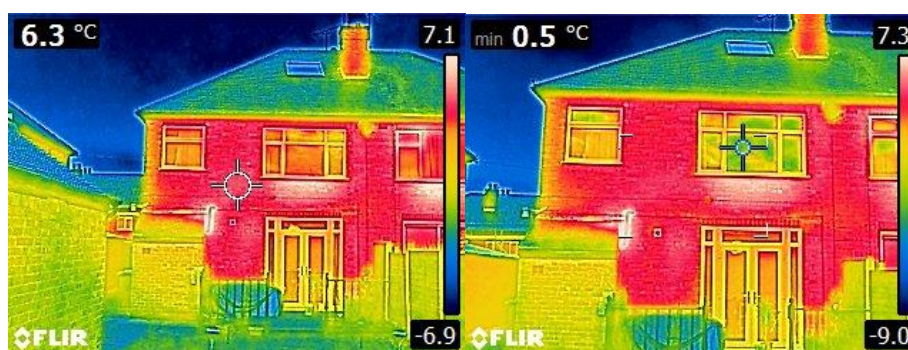
Figure 9 and Figure 10 shows the results of the thermographic imaging done at the pilot building, with visible thermal bridges on the window frames.

Figure 9 - Thermographic imaging of the back side

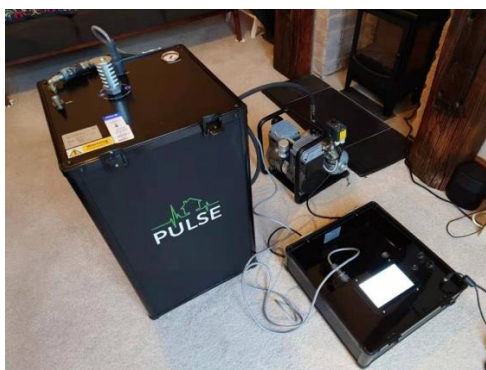
The pulse technique (Figure 11) measures the building airtightness at low pressures by releasing a known volume of air into the test building over 1.5 seconds from an air tank to create an instant pressure rise within the test building and reach a “quasi-steady” flow. Pressure variations in the building and tank are monitored and used for establishing a correlation between leakage and pressure. The method used for the adjustment, which accounts for changes in background pressure, is achieved by deducting background pressure from the raw data.

Figure 11 - Pulse airtightness test equipment

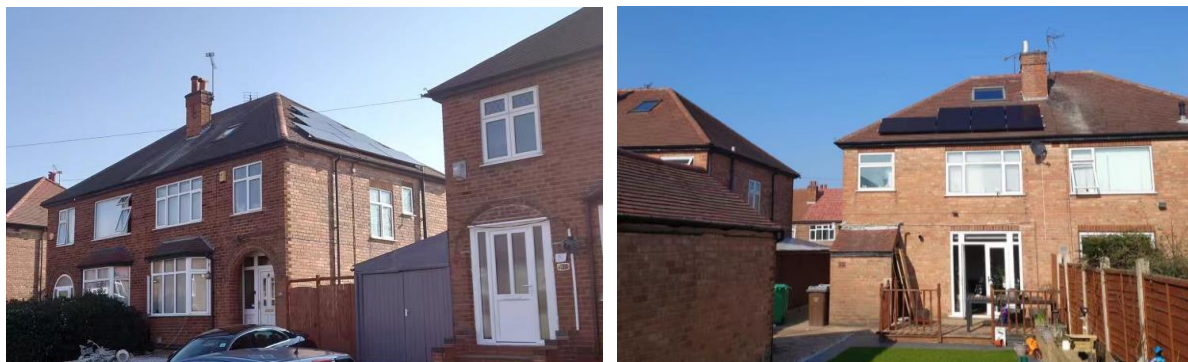
Figure 13 - PV panels installed on the west (Left) and south (Right) roof

The roof PV panels are installed in November 2021, and the performance monitoring start on 1<sup>st</sup> January 2022 to 31<sup>st</sup> December 2024 with monthly power output. The PV-Vacuum Glassing

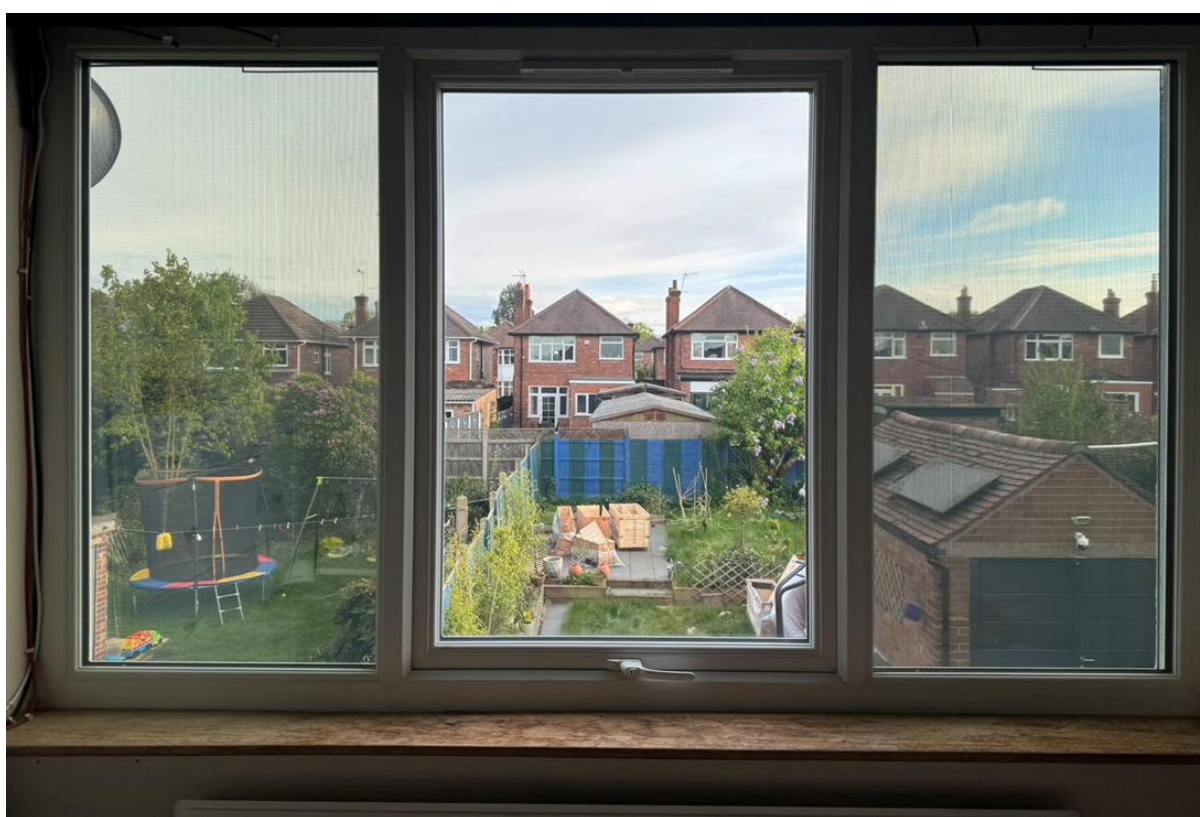
Figure 14 - Installation of the PV-Vacuum Glassing Windows unit

window was only installed in the bedroom, with the performance is monitored from 1<sup>st</sup> January 2024 to 31<sup>st</sup> December 2024 for a whole year test.

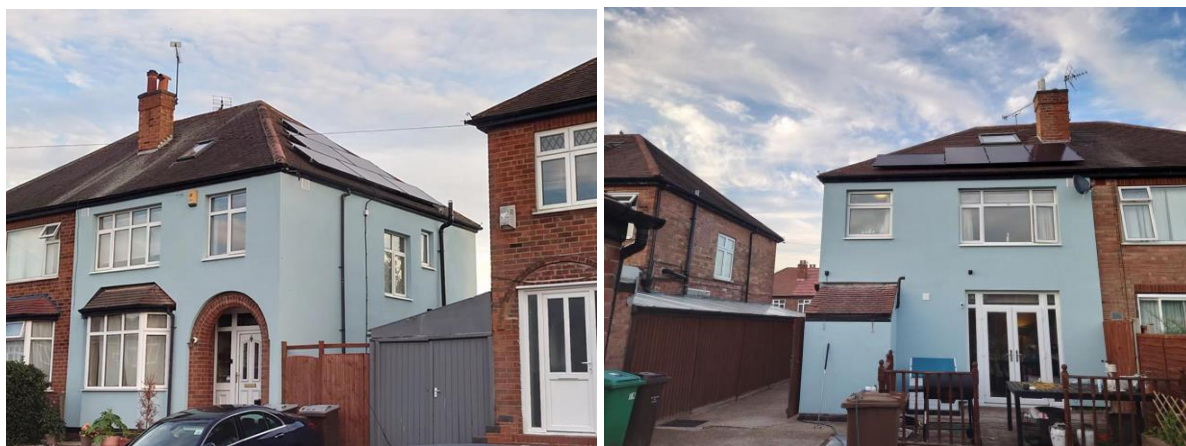
The external wall insulation using bio/silica-aerogel materials is in July 2022, and the monitoring performance start from 1<sup>st</sup> August 2022 to 31<sup>st</sup> December 2022, which is used to compare the energy performance between 1<sup>st</sup> August 2021 to 31<sup>st</sup> December 2021.

Figure 15 - External wall insulation and Solar PV Front (Left) and Back (Right)

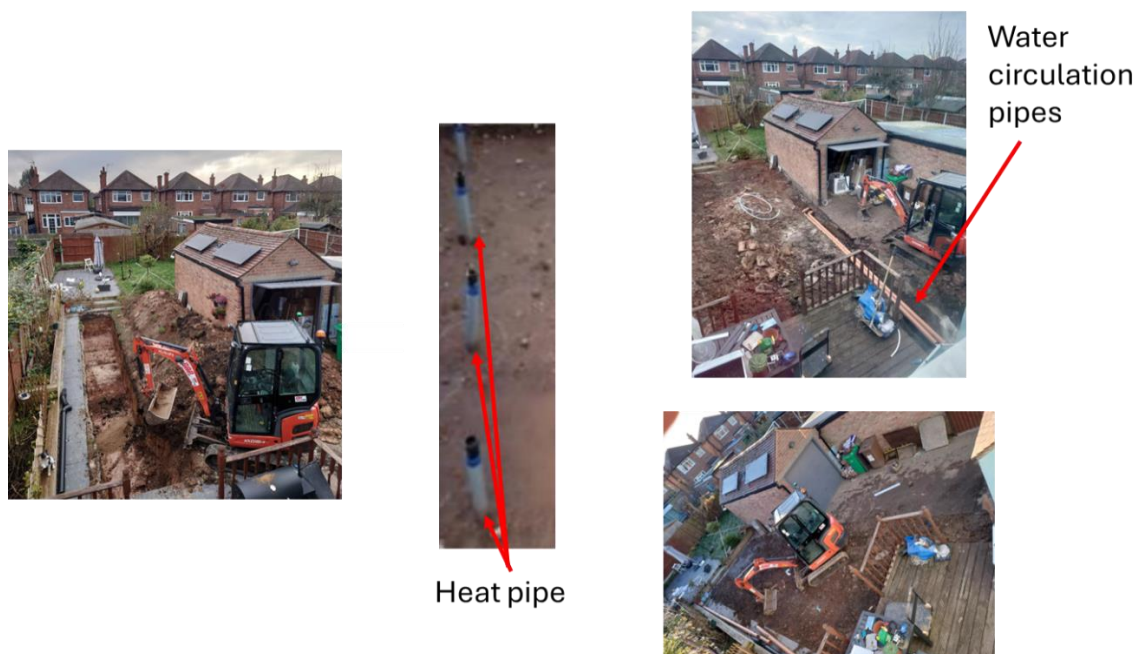
Figure 17 - Installation of the heat-pipe and water circulation pipes of the GSHP system underneath the soil

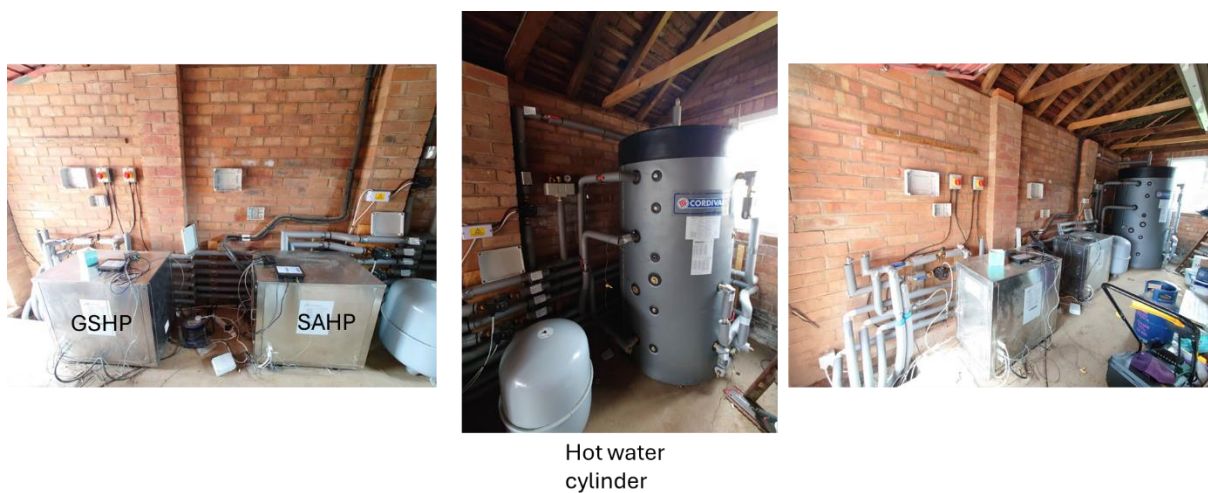
Figure 18 - Installation of both SAHP and GSHP unit and a hot water cylinder inside the garage space

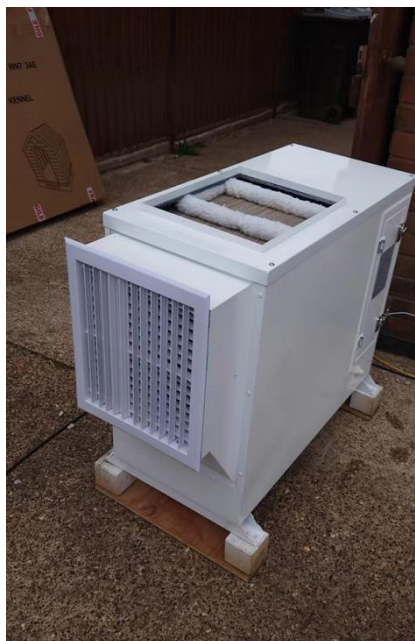
Figure 19 - Installation of the evaporative cooler

The evaporative cooler is installed in May 2023, and the performance monitoring is start in the hottest week from 23<sup>rd</sup> July 2023 to 29<sup>th</sup> July 2023.

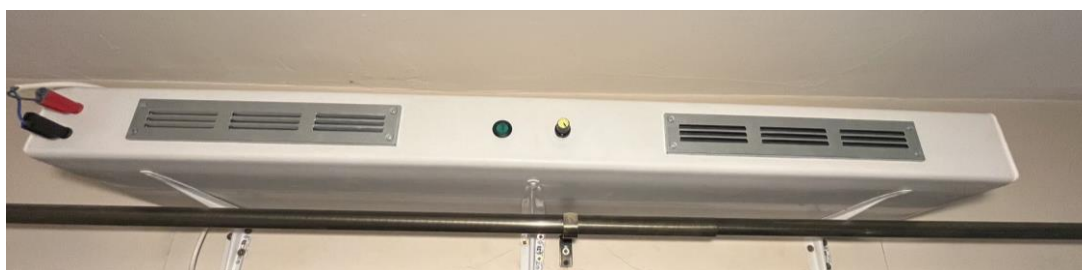
Figure 20 - Installation of the Window heat recovery inside the bedroom

The window heat recovery unit is operated to balance the CO<sub>2</sub> content inside the bedroom. The indoor air is ventilated when CO<sub>2</sub> concentration is high. The installation of window heat recovery unit is in December 2023, and the bedroom indoor air CO<sub>2</sub> content is monitored from 1<sup>st</sup> Jan 2024 to 31<sup>st</sup> Dec 2024. As all the electrical power of the window heat recovery unit is only supported by the power generation from the PV-VG unit, the electrical power is required of only 12W, which is too small and not an energy consumed unit in this project, therefore, no specific power monitored is used for this unit and only indoor air quality is monitored to evaluate the performance after the installation.

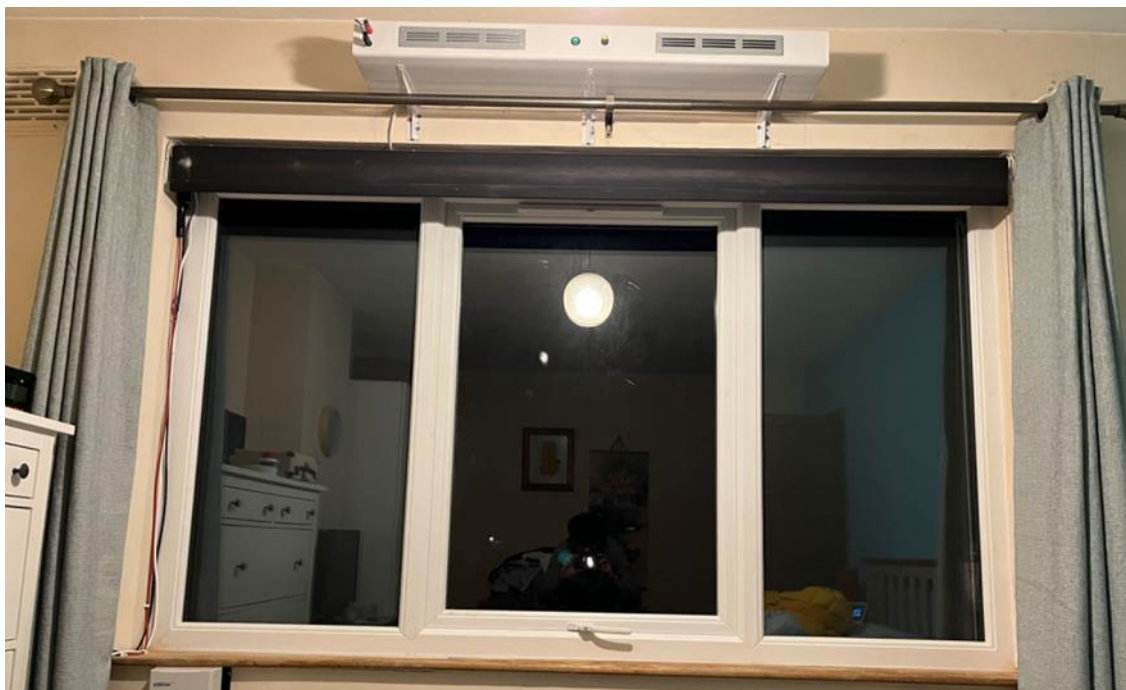
Figure 21 - Integration of Window heat recovery unit with the PV-VG unit inside the bedroom

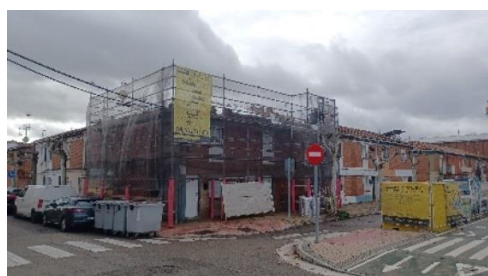
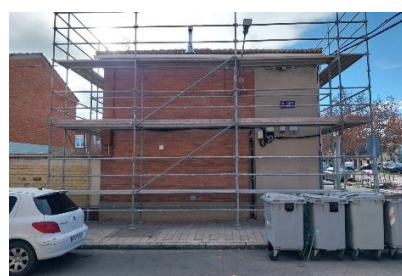
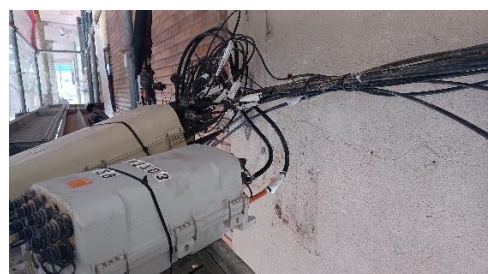
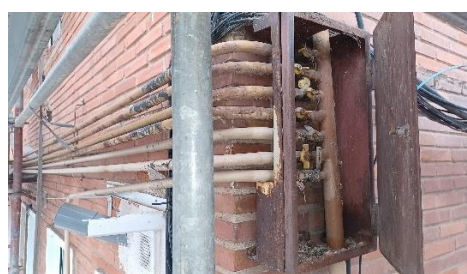
Figure 35 - Scaffolding and removing of gas and electricity installation

Following the setup of scaffolds, our first step was to coordinate with the PV/T installer to remove existing gas, telecommunications, and electrical installations. This process took considerable time, particularly in determining the final configuration and specifics of each system.

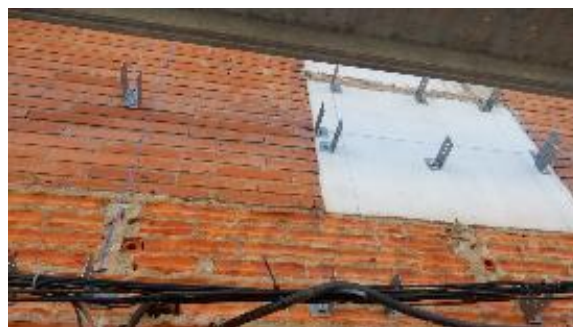
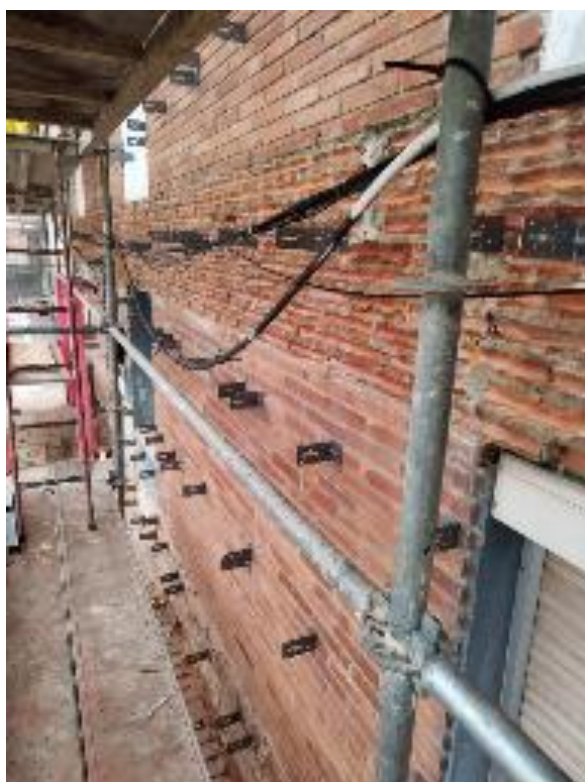
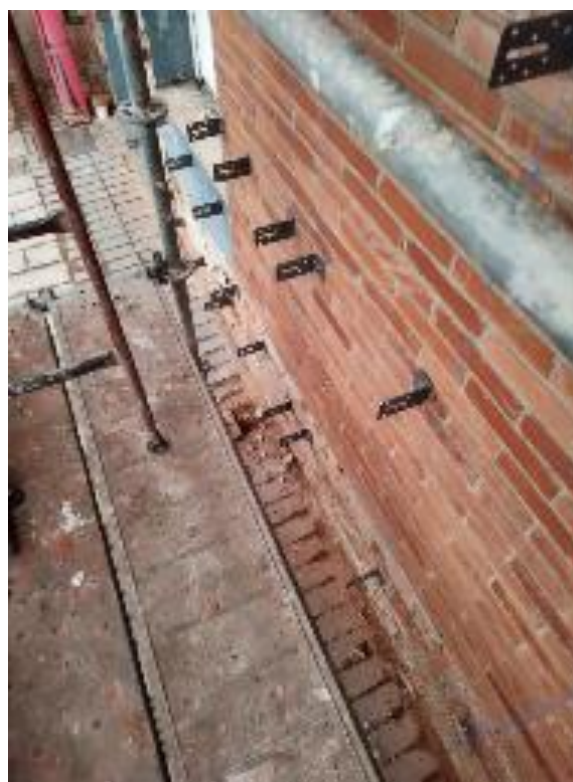
Figure 36 - Drafting and installation of anchors

A significant portion of time was dedicated to setting up brackets and battens to support the chosen finish, which involved Cement Bonded Particle Board. We engaged in an iterative

process of measurement and verification to ensure precise placement of every anchor, given the boards' strict dimensional requirements.

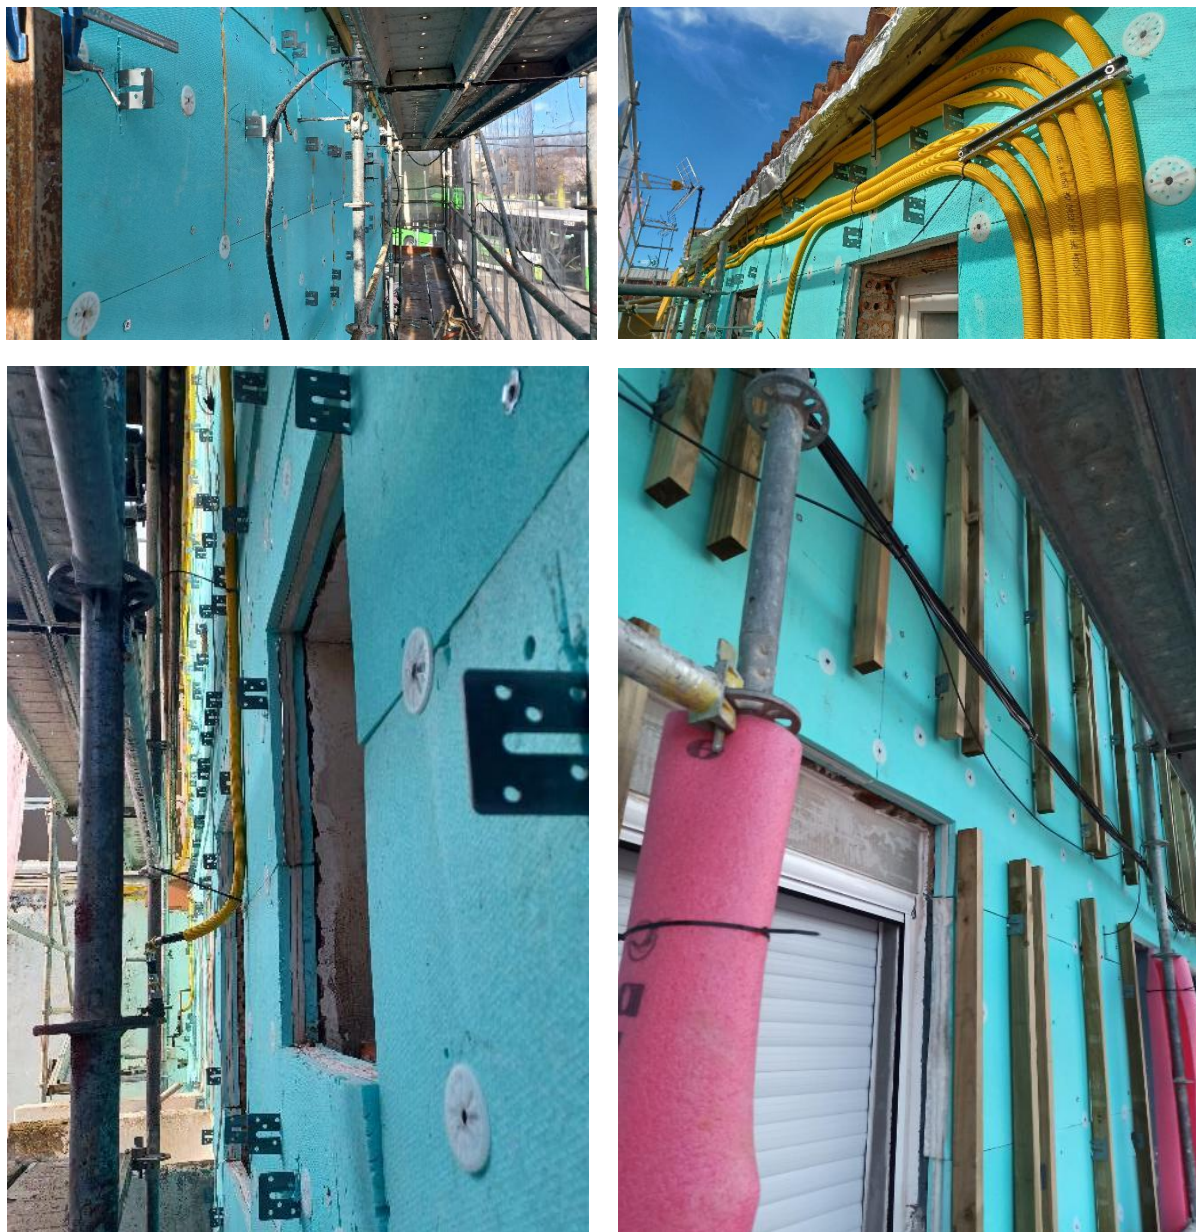
The installation of the prefabricated panel required an initial training period to achieve an efficient time-installation ratio. Notably, a major focus was directed towards the meticulous finishing of doors and windows.

Figure 37 - Installation of prefabricated panel and rafters

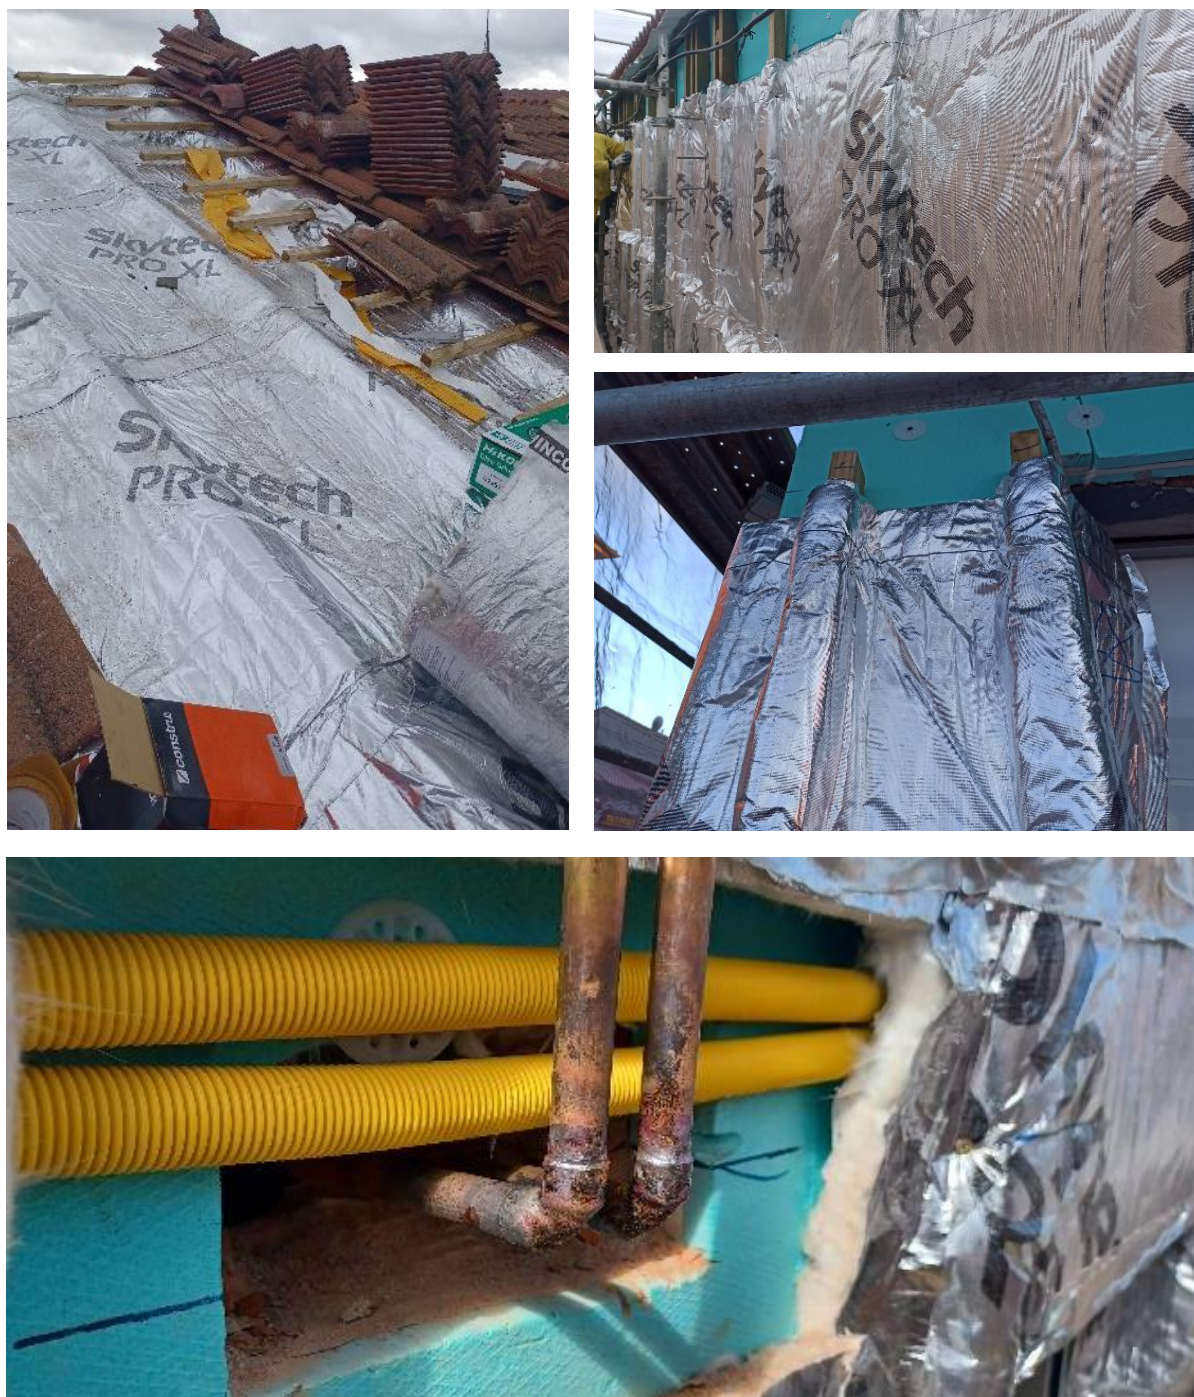
The entire process was carried out by a small team of highly skilled workers who, despite their expertise, had no prior experience with these specific technologies. This factor contributed to a delay in the overall installation timeline.

Figure 38 - Installation of the Winco rainscreen, reflective and airtightness membrane

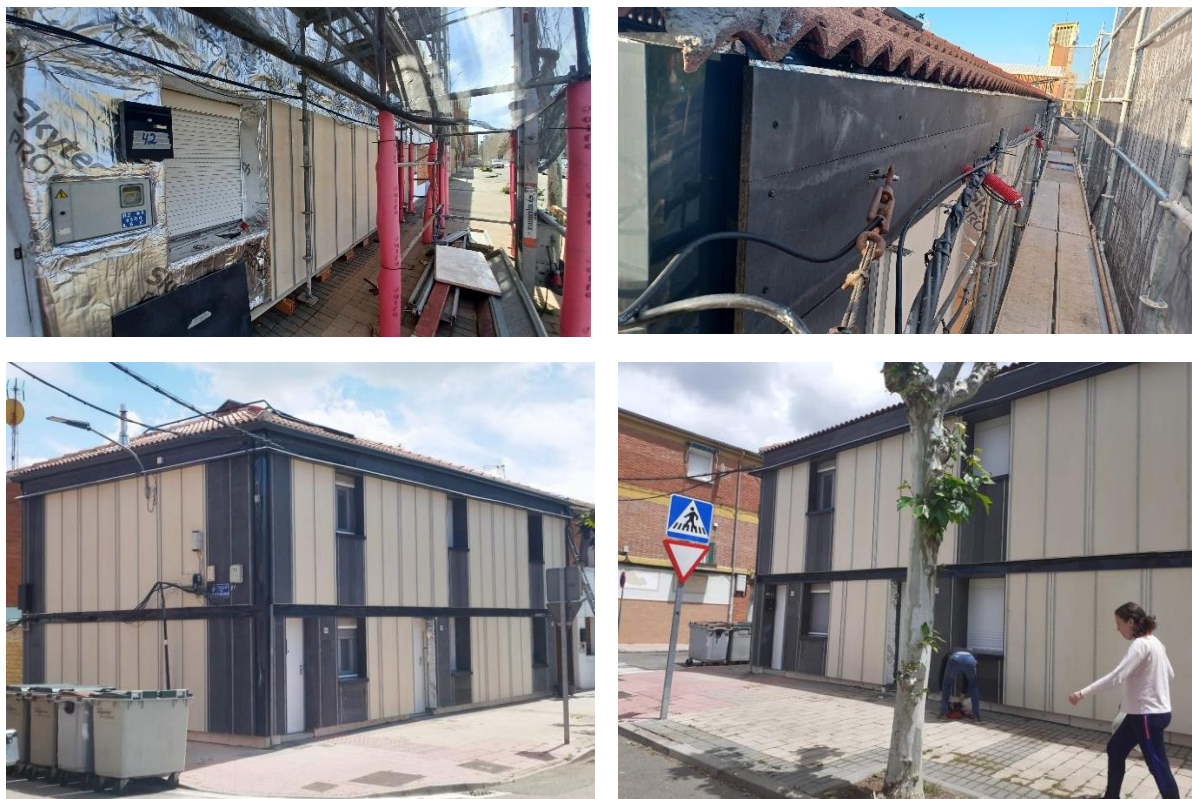
Practically, we also encountered delays in sourcing anchors, screws, and other specialized materials required for the installation. Additionally, meticulous attention was required to ensure precise dimensions following the installation of rafters, ensuring an optimal fit for the final boards.

Figure 39 - Installation of the finishing boards

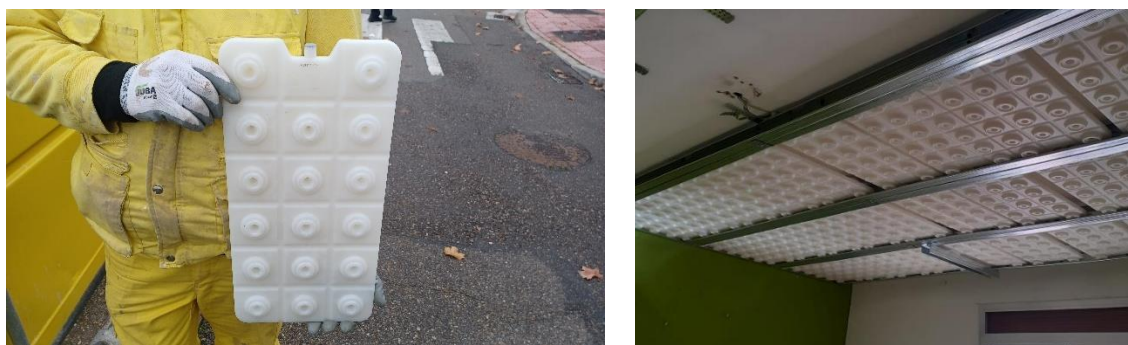
Figure 40 - Installation of PCM panels

Nonetheless, the task itself proved relatively straightforward, with no significant complications, except for the crucial consideration of avoiding drilling into the PCM blisters. Additionally, we had to plan for the installation of lighting fixtures.

Ultimately, this technology was successfully installed by mid-January.

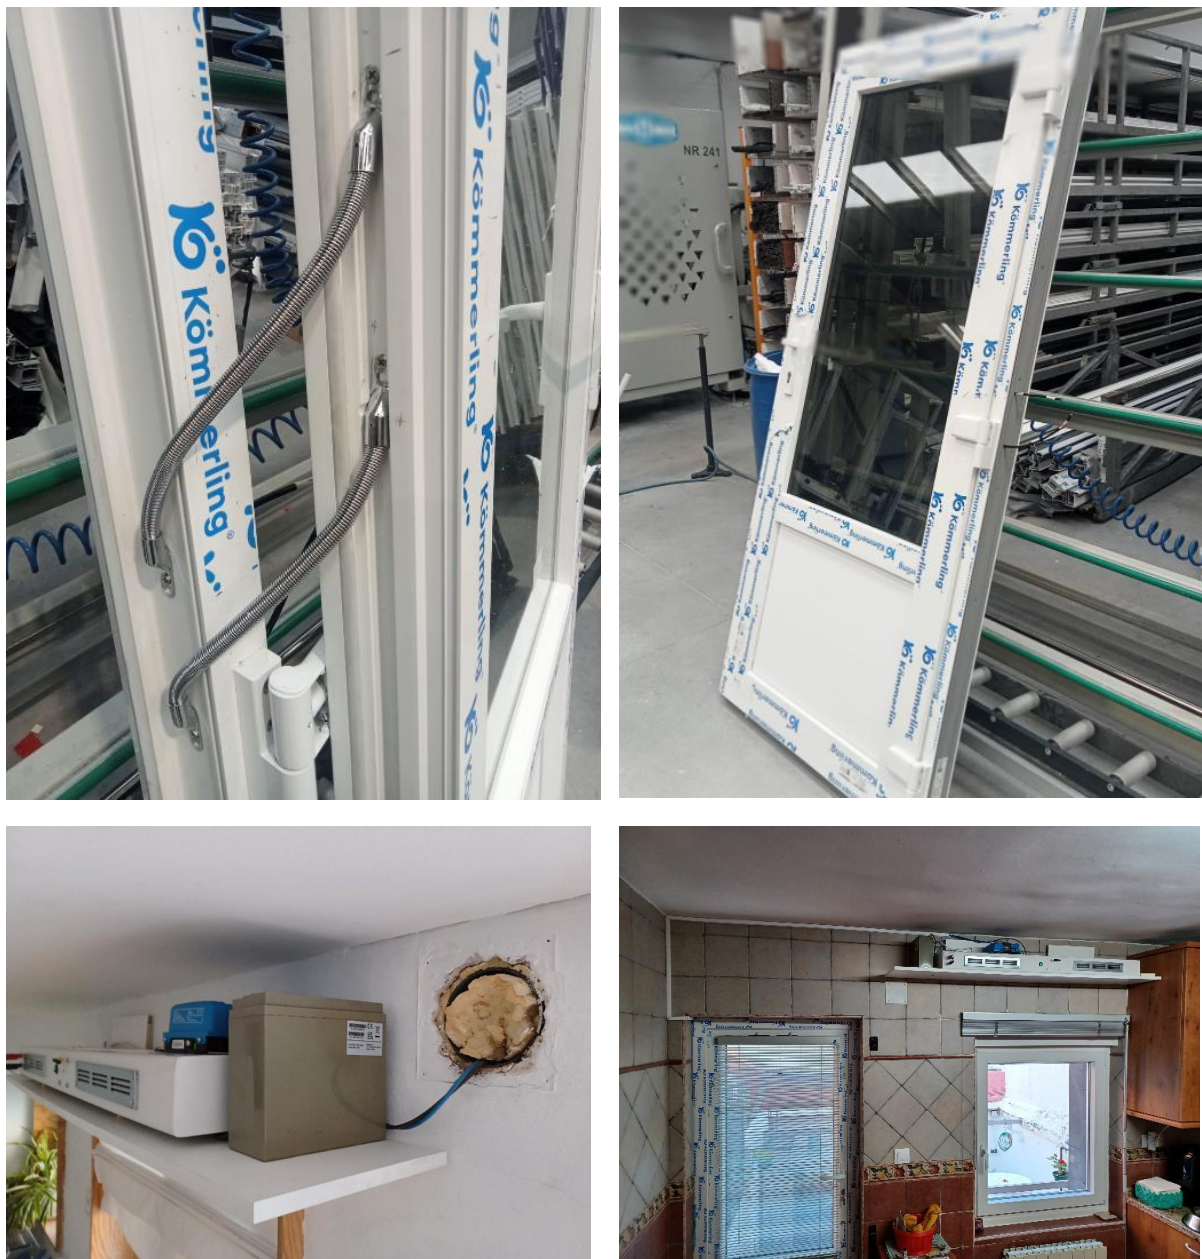
During operation, further issues were identified concerning the interaction between the board installed by OnControl in the Window Heat Recovery (WHR) system and the PV Vacuum Glazing Window. The installation included an inverter, and a battery intended to power both the WHR and the control board. However, it was observed that the system was unable to provide a stable energy supply to the board on a regular basis. As a result, it was decided to connect the WHR to the electrical grid to ensure reliable operation. The energy produced by the PV Vacuum Glazing Window is instead utilized for a secondary function, such as powering an LED light in the kitchen or any other use chosen by the homeowner.

Another challenge identified during operation is the noise generated by the system. Users have noted that the system produces a considerable level of noise, which could be a concern in residential environments. However, they acknowledge and accept this limitation as part of the implementation of an innovative technology within the framework of the project.

Figure 41 - Installation of the PV vacuum glazing window and the window heat recovery

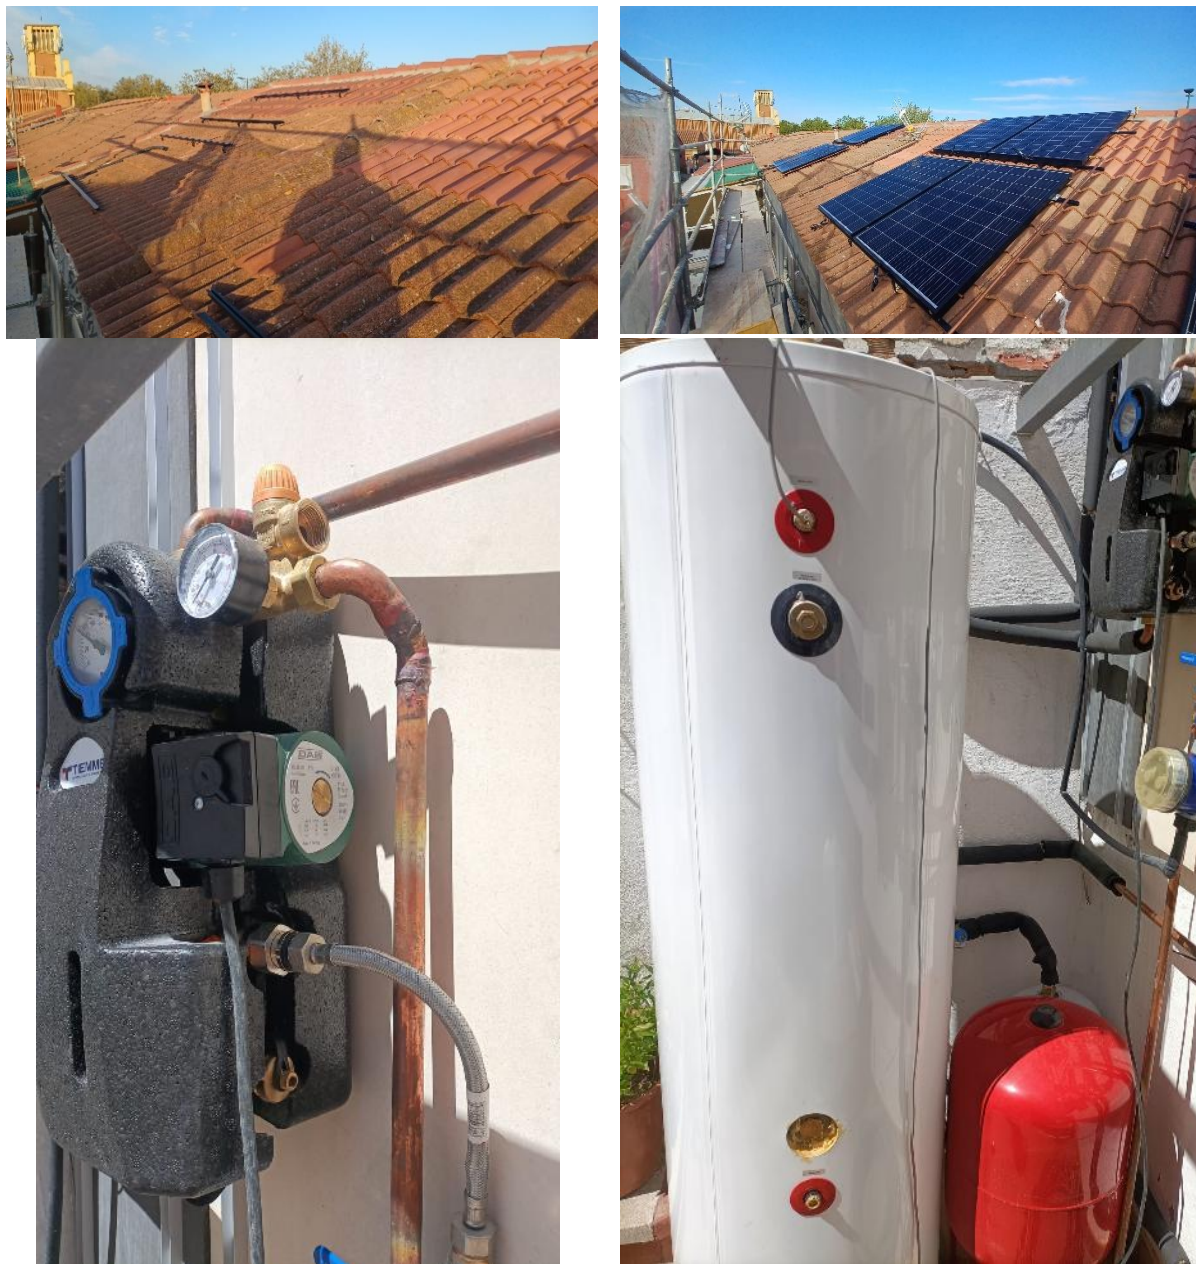
Figure 43 - Installation of the PV/T panels

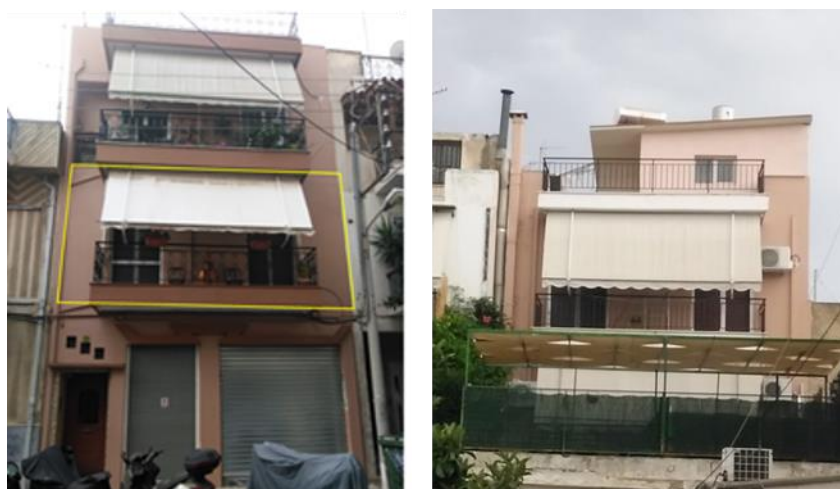
Figure 50 -The main (front) and backside façade of the building – the renovated apartment is indicated inside the yellow rectangle

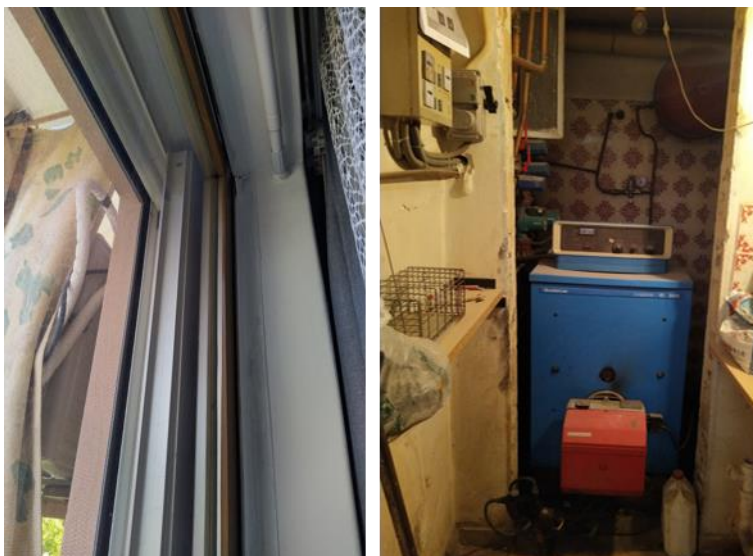
1. The window openings of the apartment demonstrated significant losses through their frame;
2. The apartment's envelope seemed to also present energy losses especially through the floor which is adjacent to the unheated ground floor of the building;
3. There was a great use of the radiators during the winter and of the air-conditioners during the summer;
4. Noise coming from external and internal sources was also mentioned from the tenants;
5. The solar collector for the DHW of the apartment was old and needed replacement.

Figure 53 - Old window frame and the old diesel boiler

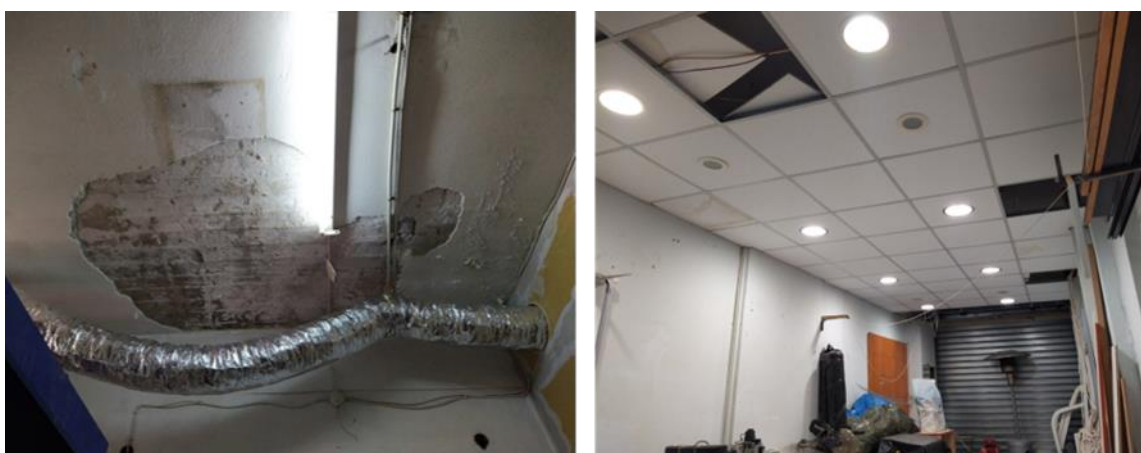
Figure 54 - The ceiling of the ground floor with which the demonstration apartment is in contact

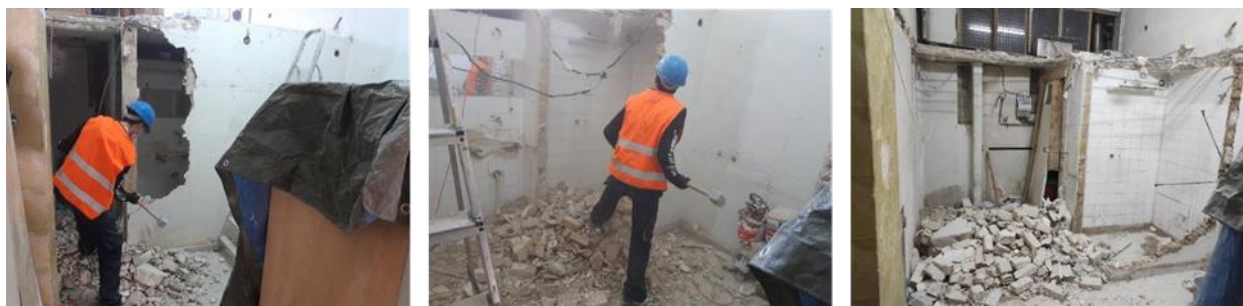
Figure 60 - Demolition of the wall on the ground floor where the water tank would be installed

First, the installation of the tank for the storage of the heated water took place, by completing the required demolition works at the ground floor of the building where the mechanical systems of the building were situated.

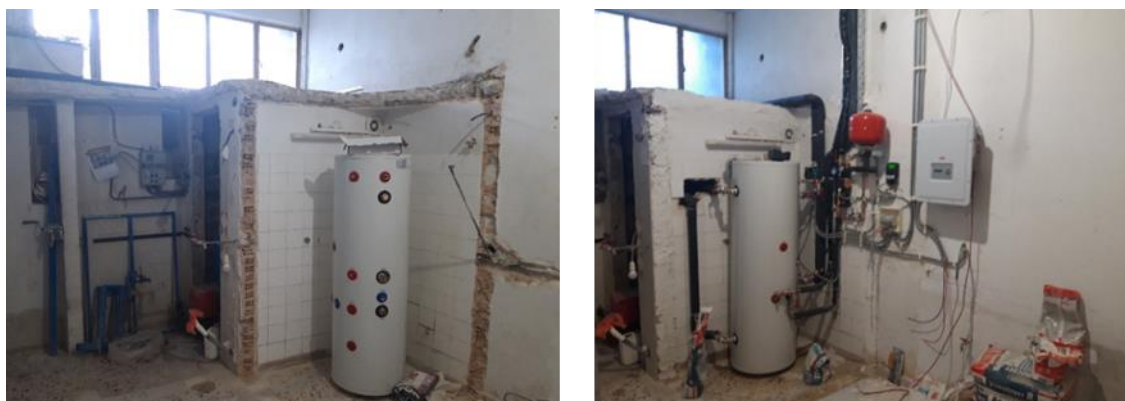
Figure 61 - Installation of the water tank and of the related auxiliary equipment

Then, the installation of the tank and of the auxiliary systems took place along with the required piping and wiring for the connection of the devices and components.

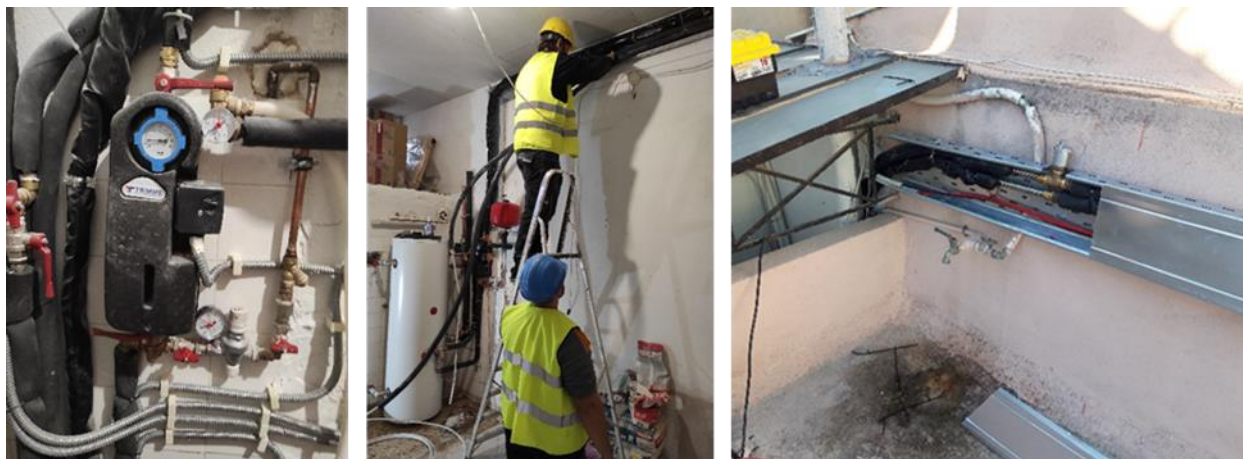
Figure 62 - Installation of piping and wiring of the PVT system

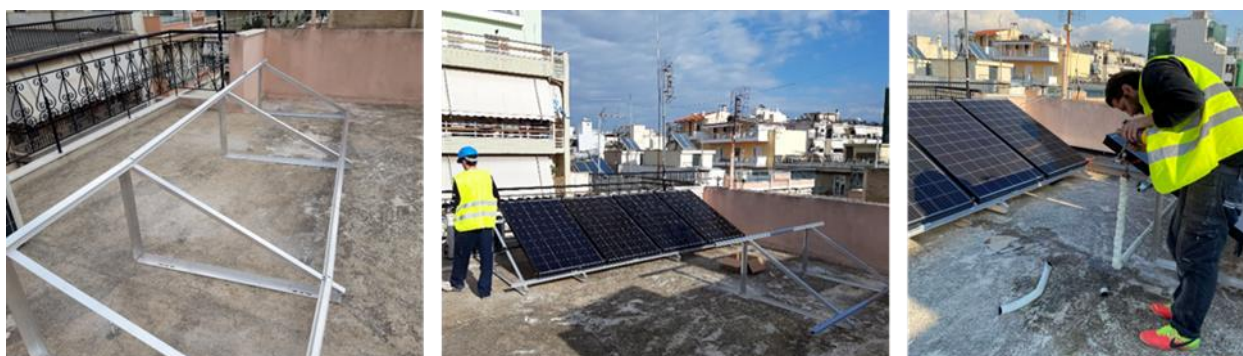
Figure 63 - Installation of the mounting system and of the photovoltaic panels of the PVT system

Finally, the Photovoltaic panels were installed at the roof of the building by the use of the appropriate mounting systems. The whole installation process has pretty much followed the steps and guidelines of a conventional photovoltaic roof system installation.

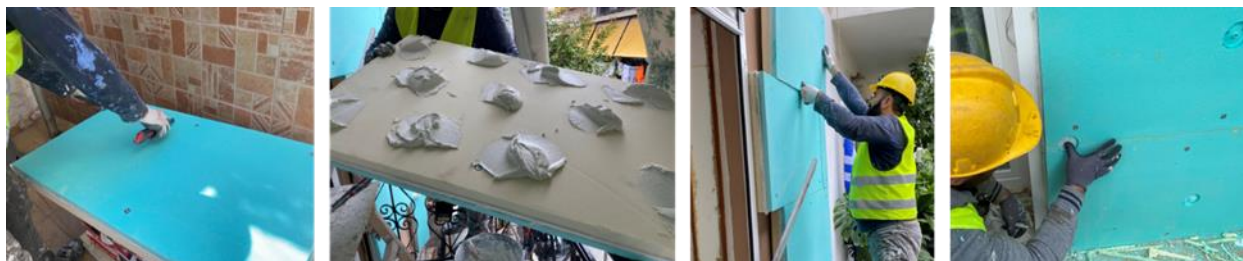
Figure 64 - Steps for attaching the prefabricated insulation panels at the existing walls (cutting, gluing, attaching to the wall, securing with plastic anchors)

The prefabricated panels were applied upon the existing walls by following the installation steps of an ETICS installation. The pieces were cut on the required sizes/dimensions and then were attached with the appropriate insulation glue upon the walls. Then, the panels were secured upon the walls by the use of PVC anchors and at the end a fiberglass net was used to cover all the insulated surfaces and to strengthen them. The mesh was attached by the aid of insulation glue. The final surface was coated by 2 layers of insulation glue and a layer of plaster at the colour of the building's facades.

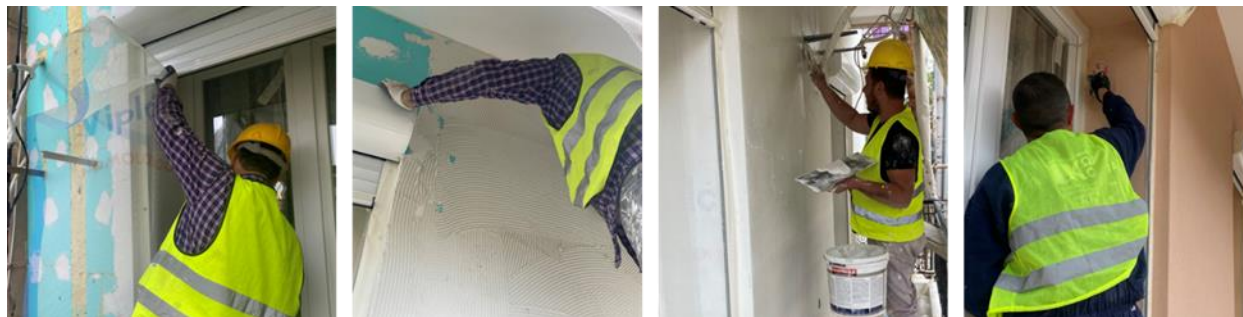
Figure 65 - Installation of the fiberglass mesh, applying the glue coatings, smoothing the surfaces, applying the final paint

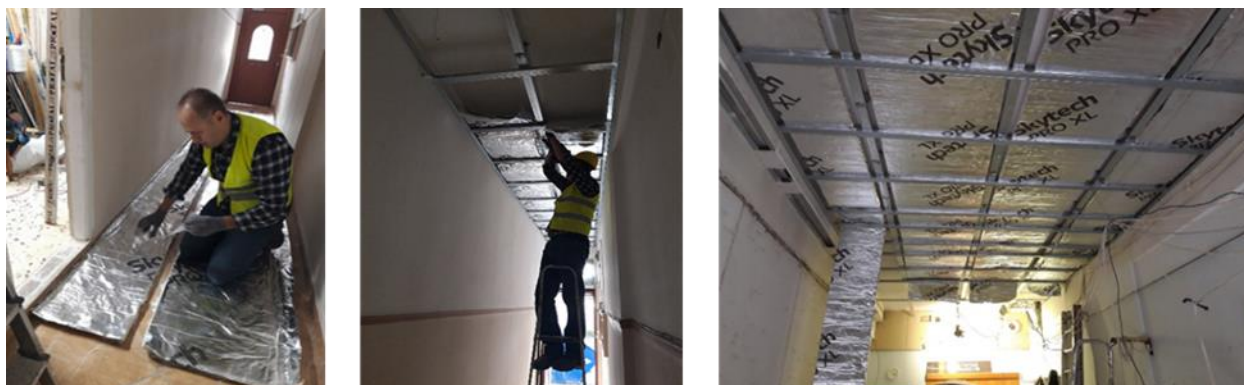
Figure 67 - Preparing the WINCO membrane and the new ceiling frame for the installation of the membrane

As is indicated in the following pictures, the ground floor had already installed a false ceiling as it was used as a workshop-office space. The first step was to remove the false ceiling (*Figure 18*) and then create a new framed construction (like that of a false ceiling) which would be utilised for the integration of the membrane (*Figure 19*).

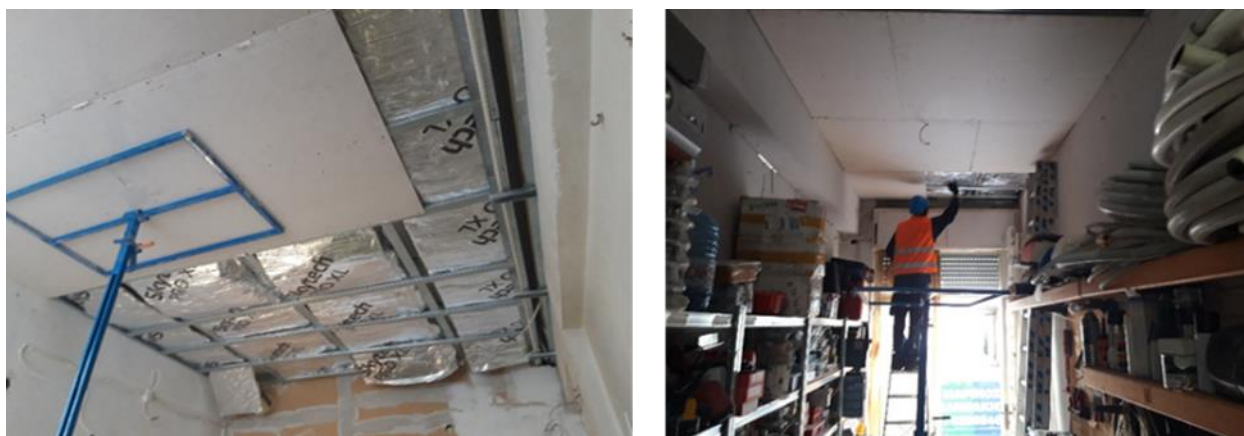
After the installation of the membrane, new false ceiling panels should be applied to cover and protect the breathable membrane (Figure 20).

Figure 68 - Installation of false ceiling panels
