## **S**ustainable solutions for affordable **REtroFIT** of domestic buildings

### **WP9 - Deliverable D 9.6**

#### **Report on case studies of retrofitted buildings**

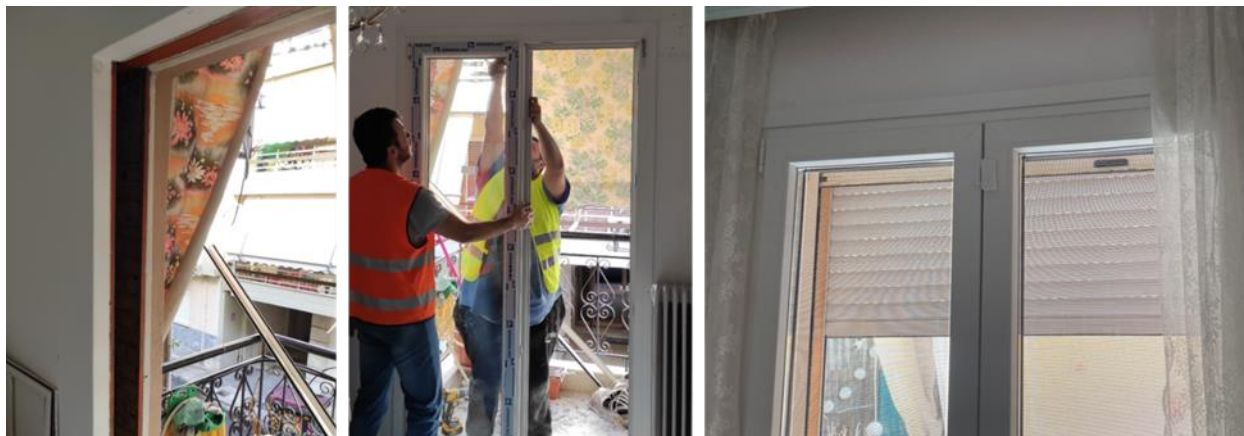
Figure 69 - Removal of old window and balcony doors and installation of new ones

The windows and balcony doors of the house were replaced by new double, low E and PVC framed windows and in one of the balcony doors of the south façade, the glazing of the PVC framed door was replaced by the PV vacuum glazing. Moreover, new roller shutters were installed for enhancing the thermal behaviour of the openings.

After the attachment of the PV vacuum glazing inside the PVC frame door, the wiring of the PV film was connected to the auxiliary devices so as to be able to use the produced electricity.

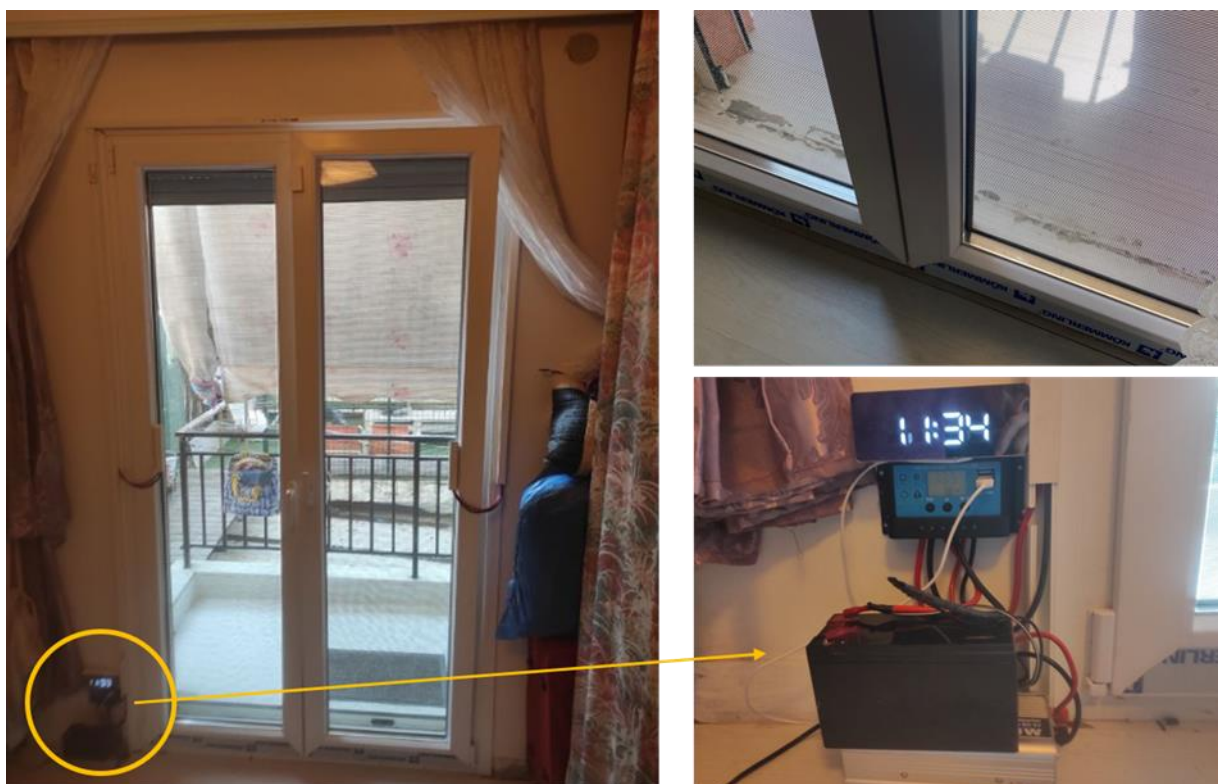
Figure 70 - The PV vacuum glazing installed inside the aforementioned balcony PVC door and the auxiliary devices

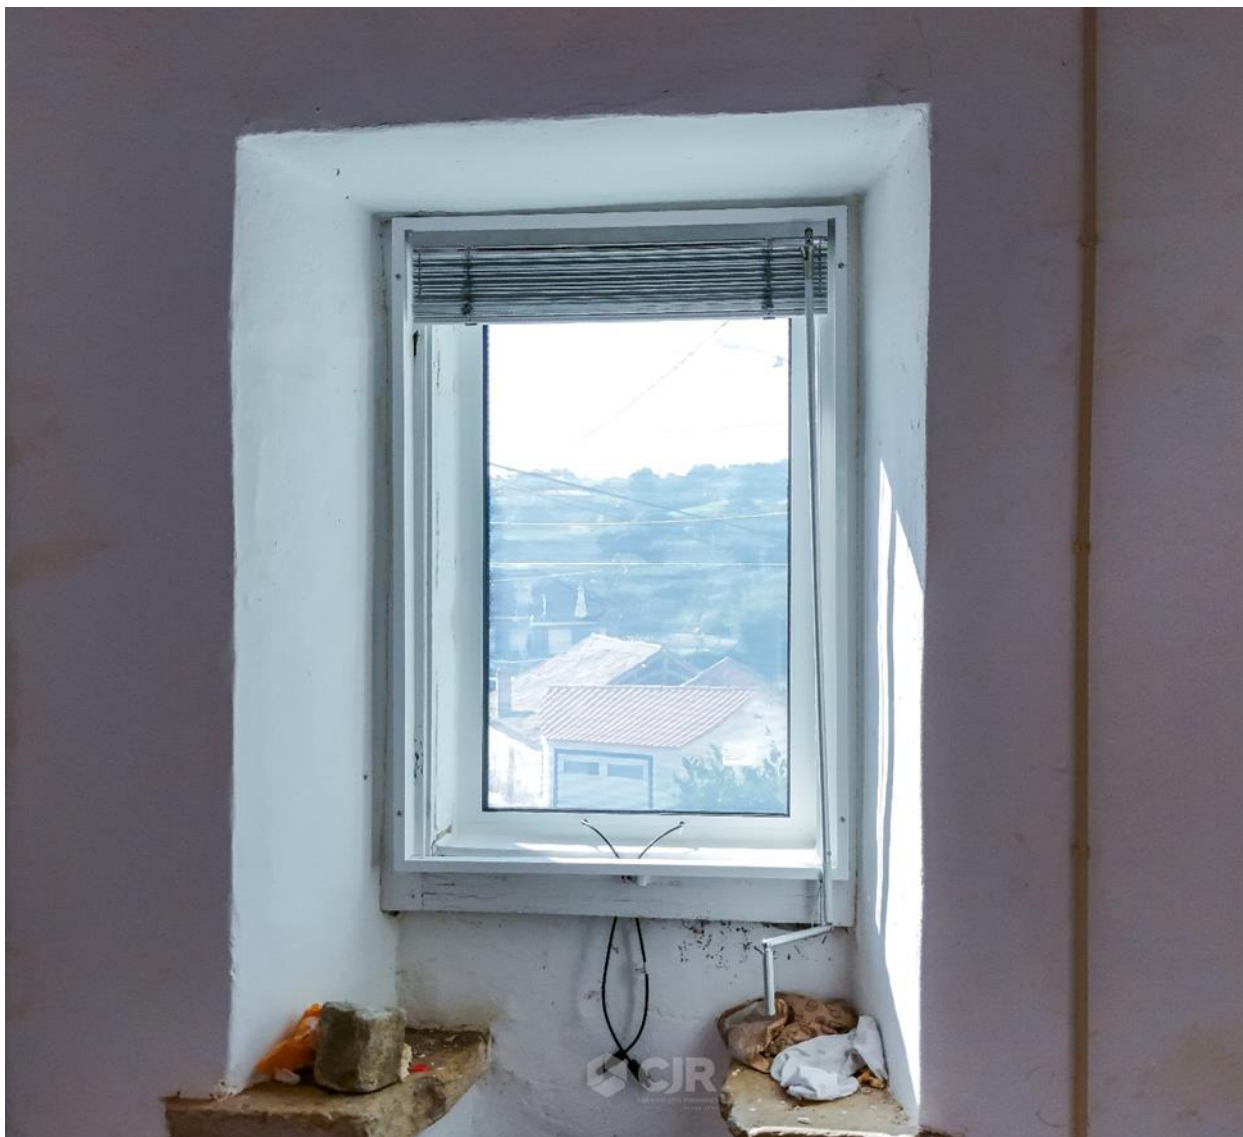
- **PV Vacuum Glazing:** Vacuum glazing that improves thermal insulation, reducing heat loss through windows. The integration of photovoltaic cells enables electricity generation, contributing to sustainability.

Figure 75 - PV Vacuum Glazing - Portuguese demo case

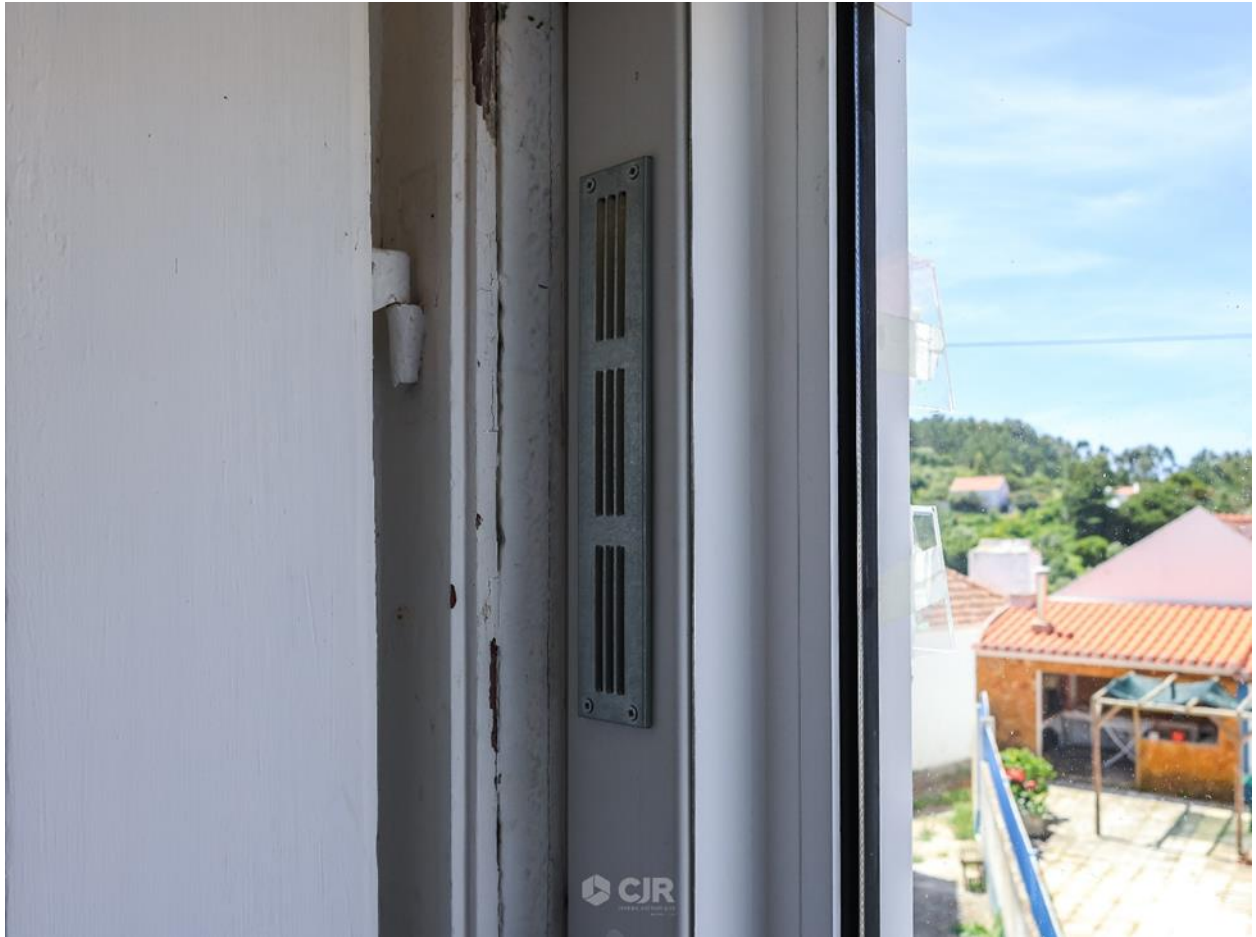
- **Window Heat Recovery:** A system that recovers heat from exhaust air to preheat incoming fresh air, reducing heating energy demand and increasing HVAC system efficiency.

Figure 76 - Window Heat Recovery - Portuguese demo case

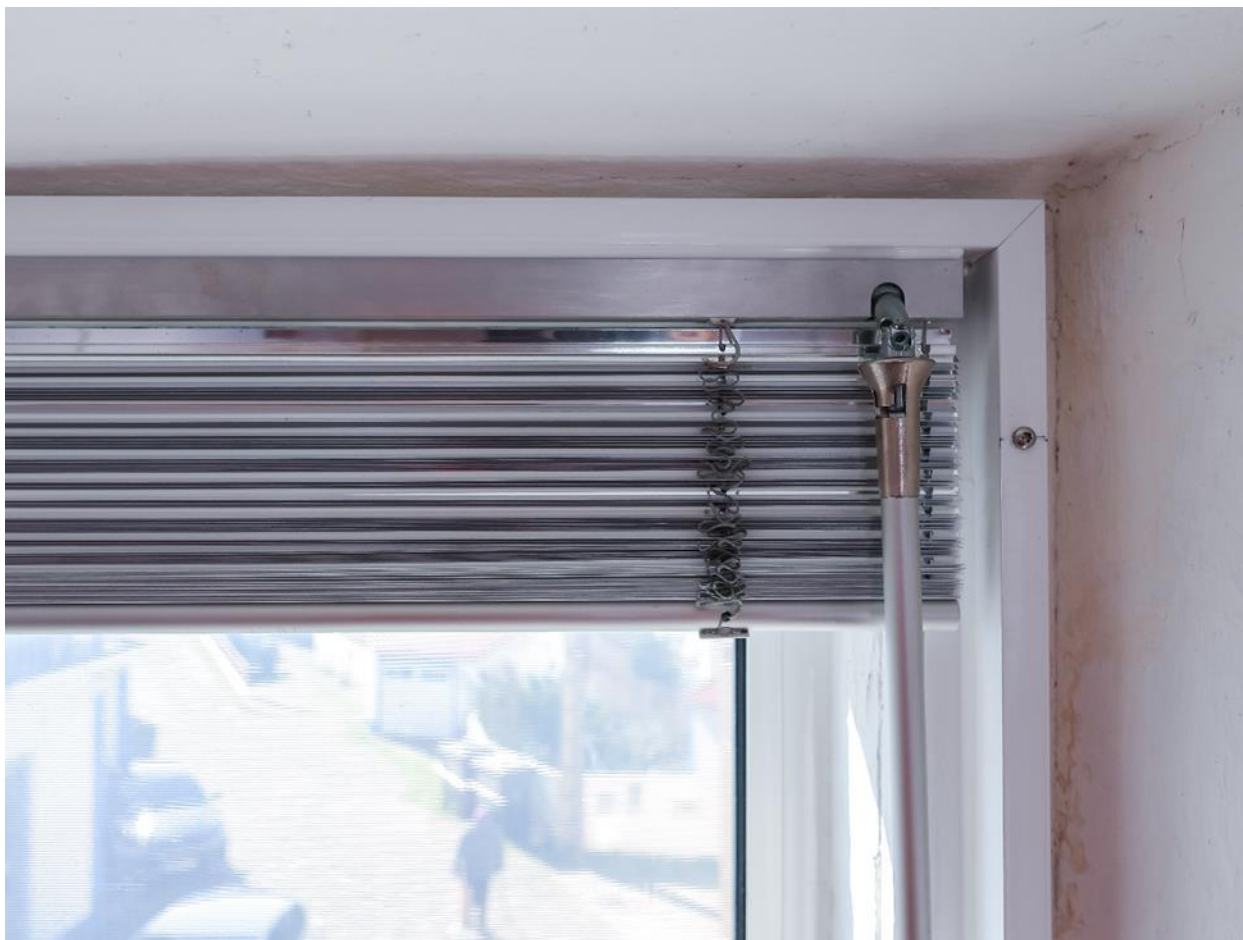
- **Daylight Louvers:** Adjustable devices that maximize natural light entry, reducing the need for artificial lighting and improving internal lighting quality.

Figure 77 - Daylight Louvers - Portuguese demo case

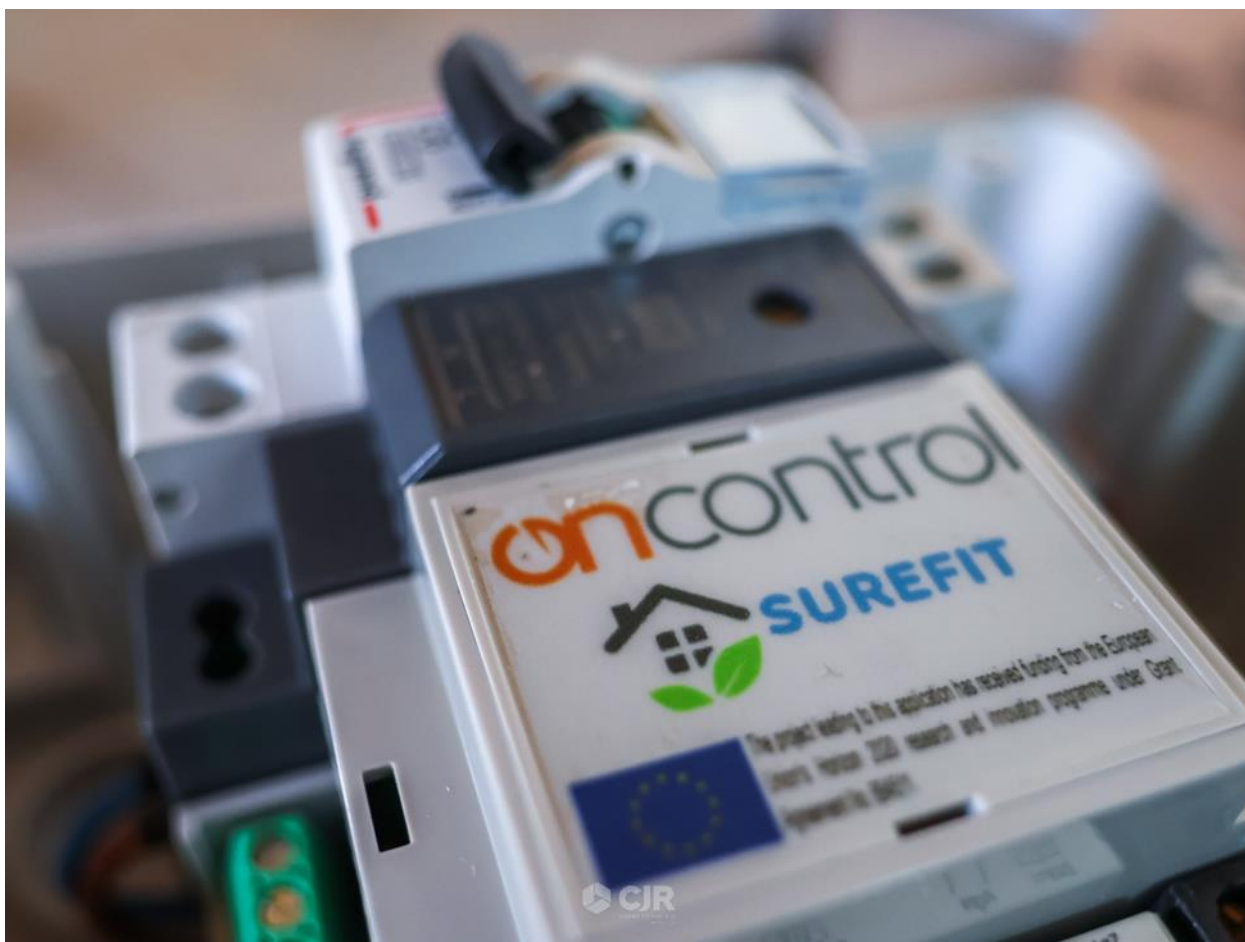
- **Smart Controls:** Advanced control systems that automatically manage heating, cooling, and ventilation. These systems adjust parameters based on environmental and occupancy data, optimizing energy consumption and providing greater comfort.

Figure 78 - Smart Controls - Portuguese demo case

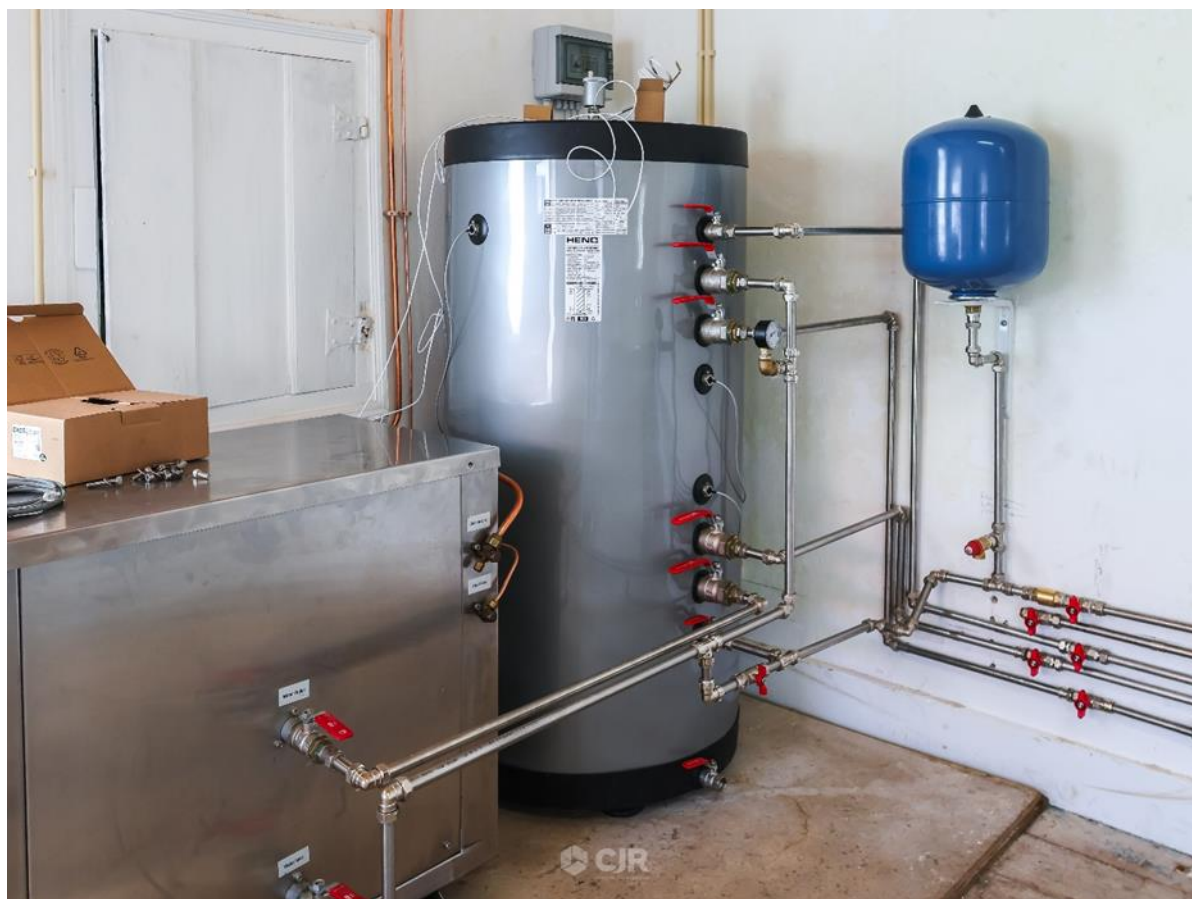
- **Solar-Assisted Heat Pump:** Hybrid heat pumps that combine traditional technology with thermodynamic panels, reducing conventional energy consumption and promoting a sustainable heating solution.

Figure 79 - Solar-Assisted Heat Pump - Portuguese demo case

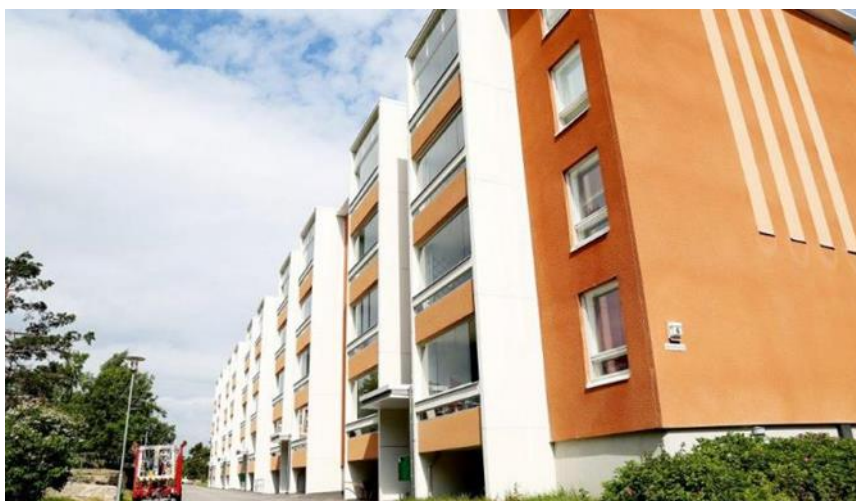
The Finnish demo building is shown in *Figure 5.1*. It's a rental apartment building in Helsinki, owned by the municipality. There are four residential storeys and a basement area, which contains garages, storage rooms and a common sauna section. Each apartment has two bedrooms, a living room, a bathroom, and a kitchen with a dining area. The apartments are connected to the central hallway.

Figure 87 - Finnish apartment building

The building underwent a conventional energy renovation between 2022-23. During this renovation, a hybrid heating system comprising ground source heat pumps and district heating was installed. This replaced the old fully district heating -based system. PV panels were installed on the roofs to improve the share of renewables in energy use. The airtightness of the building was improved by replacing the window and door seals and by improving the balcony wall insulation, bringing the infiltration rate under 50 Pa pressure difference from 3 ACH down to 1.5 ACH. The original mechanical exhaust ventilation system without heat recovery was replaced with balanced mechanical ventilation equipped with heat recovery.

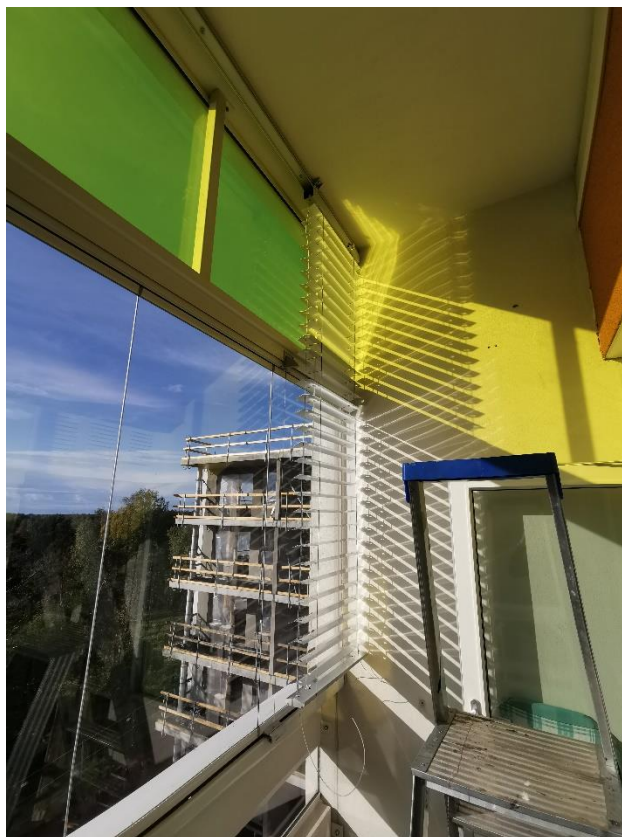
Figure 90 - Balcony louver pack and its light reflection pattern
